# The Intrepid Airmen

January 2013

## Skybolt News December 2012

by Andy Werback

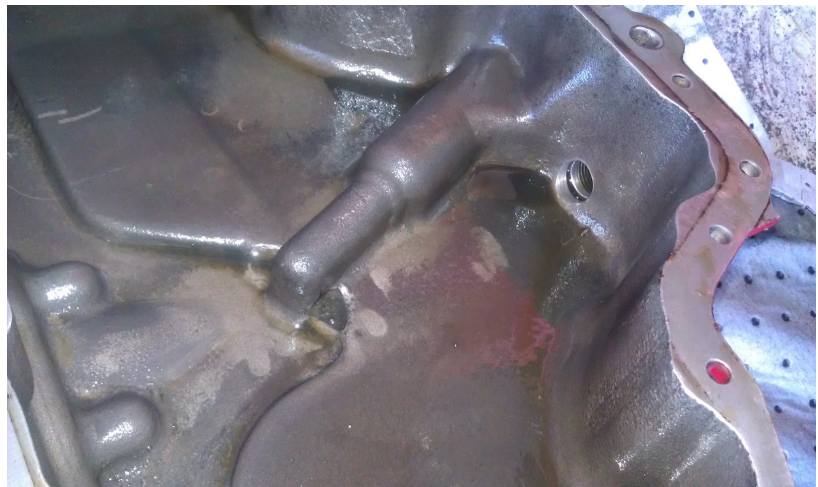
So we decided that it was time to take off the oil pan and look for maybe a leak in the oil pan gasket or a hole in the sump pickup. Note that on this engine, the normal oil sump has been plugged and a new pickup installed so that the oil from the pan goes out to the inverted oil valve before going back into the fitting where the oil screen goes to the suction inlet of the oil pump. (Easier shown with a picture!). What we found was:

In the picture to the right, the normal oil pickup in the center of the sump (which works just fine) is disabled, and the oil comes from the aft pickup port. There is a possibility that port is generating a vortex and sucking air as there is a Lot of oil being pumped through the engine.

photo shows disabled oil pickup (center) and new pickup at the aft end of the pan (right)

Steve's solution was to create a suction tube with distributed holes to minimize the chance for generating a vortex. This is a lot like the normal way of installing the Christen inverted system, except that it's off to the side instead of in the middle of the sump. According to Steve's research (a Lycoming bulletin and some other sources) this particular IO-360 model is troublesome in the oil sump area. Oops. Steve also discovered that the old style oil pressure regulator (with internal washers used to control the

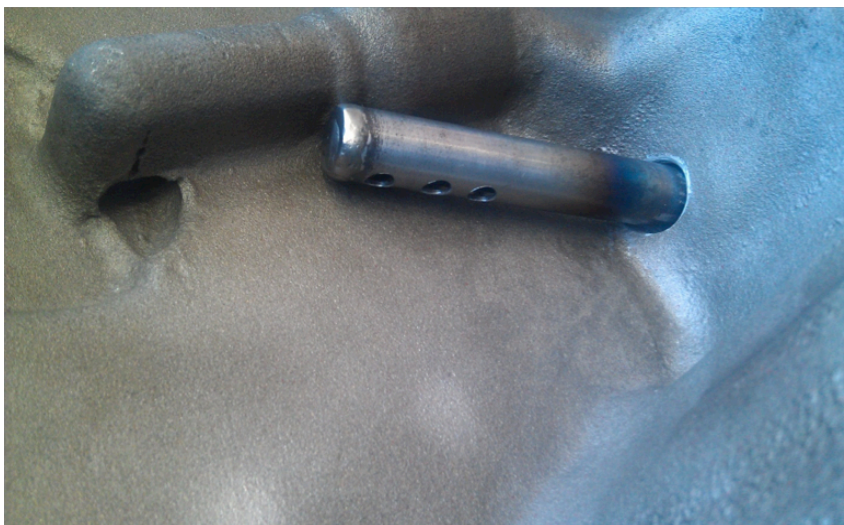
new antivortex suction tube installed

pressure relief limit) was a poor choice for an aerobatic engine with external oil system—it wouldn't regulate very well. The solution was to install the new model regulator with the external screw adjustment.

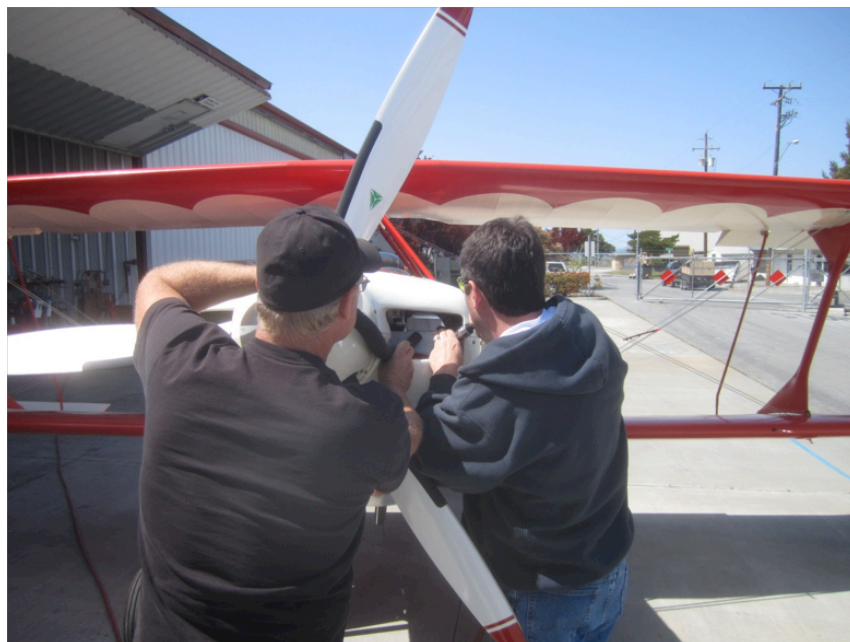
Oil temperature was and continues to be another root canal. After about 20-25 minutes, it would just climb on up to 240 degrees and stay there, regardless of engine power or pitch attitude. Not very much fun. We started by trying to make sure there was adequate airflow over the cooler, and then tried to get as much more as possible. As mentioned earlier, we opened up the cowling and cut away some baffling that might have been restricting air, but no change. CHTs, strangely, were all good (around 330-360 deg.) for an engine that wasn't broken in.

After some research, we determined that there probably wasn't enough capacity in the oil cooler I had

baffle mods

installed. It was more appropriate for an IO-320. But since it came with the boxes of parts for the airplane, I assumed it was the correct size. But it's a little hard to tell, because I could only give it a 3" SCAT tube (duct) from the back of the #3 cylinder baffle, so maybe it's just not getting enough air. In any event, Steve installed a second oil cooler on the left side of the engine, and removed the cabin heat (who needs it?) so he could install a second 3" SCAT air supply. The second cooler helped a lot, at least it got us to where we could fly the airplane for more than 25 minutes. We are able to fly continuously at moderate power, but we still have limitations on

So the next big thing is to install an airspeed indicator to show the differential pressure between the upper and lower cowling. I suspect that there isn't a lot of pressure differential, which means not enough air is getting in though the nose bowl inlets (they're sort of small and tight).

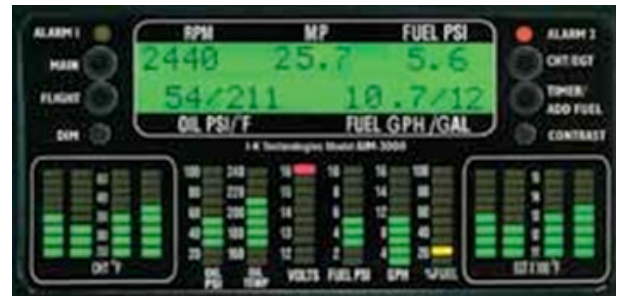
AIM-3000

Another thing that caused problems was the electronic oil temp/pressure indicator, an AIM-3000. This item fits my panel space, but I highly do *not* recommend it. We checked transducer calibration and tried a couple different transducers, and found that oil temperature indication was close but always behaved poorly around 235 degrees (where we really wanted good data), and the oil pressure was indicating about 10 psi different from an external round gauge. So we also installed a couple of new gauges for better data, and a separate electronic tach as we weren't getting any tach display from the (now disabled) electronic ignition system. Electronics International makes a nice box (well documented, has good factory support) that has just numeric displays, and is about the same size. Something to consider for later on.
